# HRV Information

## Nutech R. Hldngs Inc. Launches No-Charge Inspection Program for Heat Recovery Ventilators (HRV's) Manufactured between 1992 to 1998

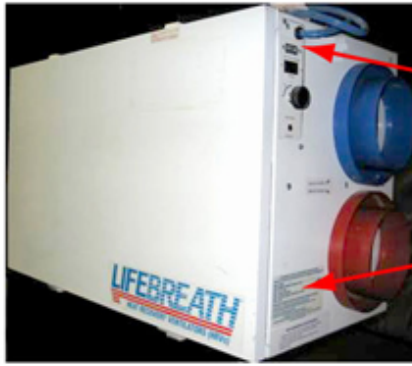
**Figure 1**

**Electrical Cord Location**

The electrical cord is normally located on the upper right end of the unit

**Name Plate Location**

The name plate is normally located on the lower right end of the unit.

Locate the electrical cord (**Figure 1**), unplug the *HRV* from the electrical outlet and find the date the *HRV* was manufactured through the serial number on the manufacturer's name plate. Write down the serial number. Serial numbers containing the numbers 29, 39, 49, 59, 95, 96, 97, or 98 will qualify for an inspection unless the original white motor has been replaced (replacement fan motors are grey or black). Refer to the attached instructions on how to locate the serial number name plate.

Locate the electrical cord (**Figure 1**), unplug the *HRV* from the electrical outlet and open the front access door. Note the color of the fan motor (usually located on the right side of the *HRV* [**Figure 9**]). Fan motors affected by this inspection program are white in color. If the fan motor is white, please leave the *HRV* unplugged, close the front access door and contact us. If the fan motor is grey or black then the *HRV* is not affected by this inspection program. Call our toll free number at **1-866-557-0535** if the fan motor is not visible.

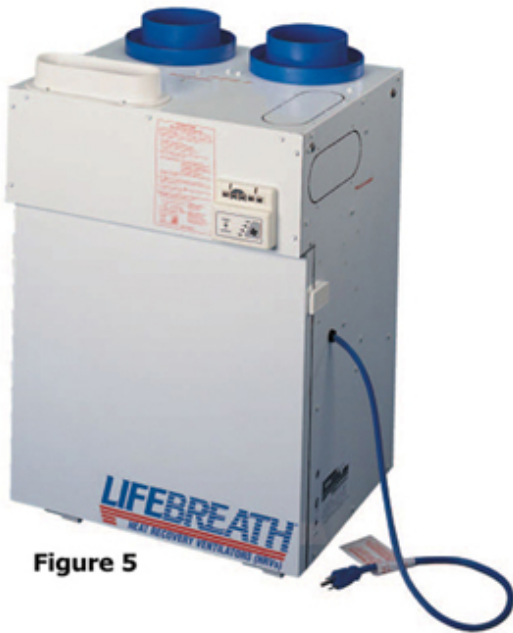
Figure 5

**HRV Styles of Affected Units**

An HRV, installed near your furnace, is a compact, electrically-powered unit designed to improve air quality inside your home in an energy efficient manner. The HRV typically has dimensions of 33" x 19" x 15" (refer to figures 5 to 8).

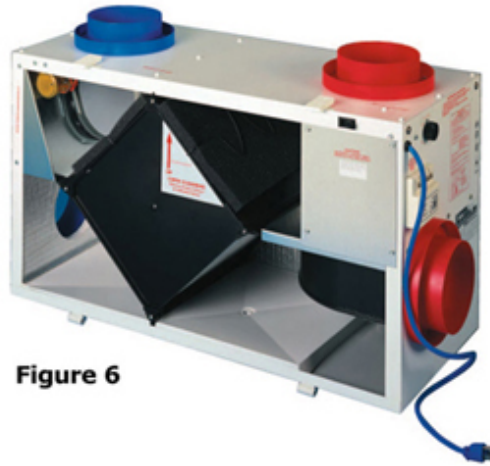
Figure 6

### 95 Series HRV's

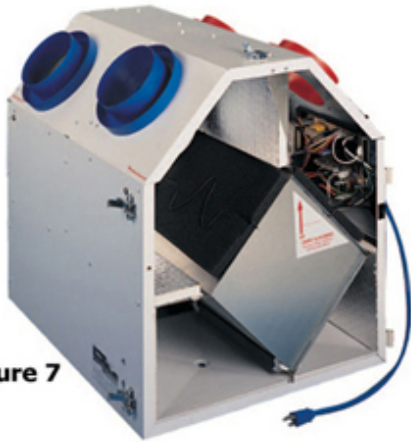
Figure 7

### Single Core Series HRV's

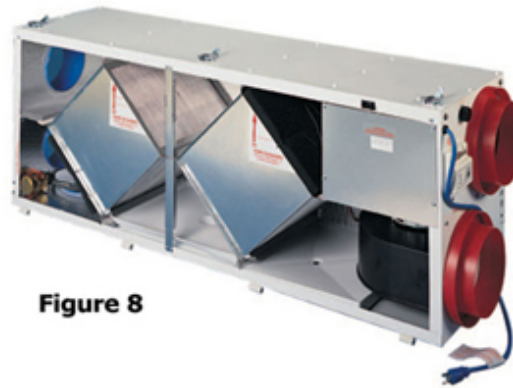
Figure 8

### Top Ported Series HRV's

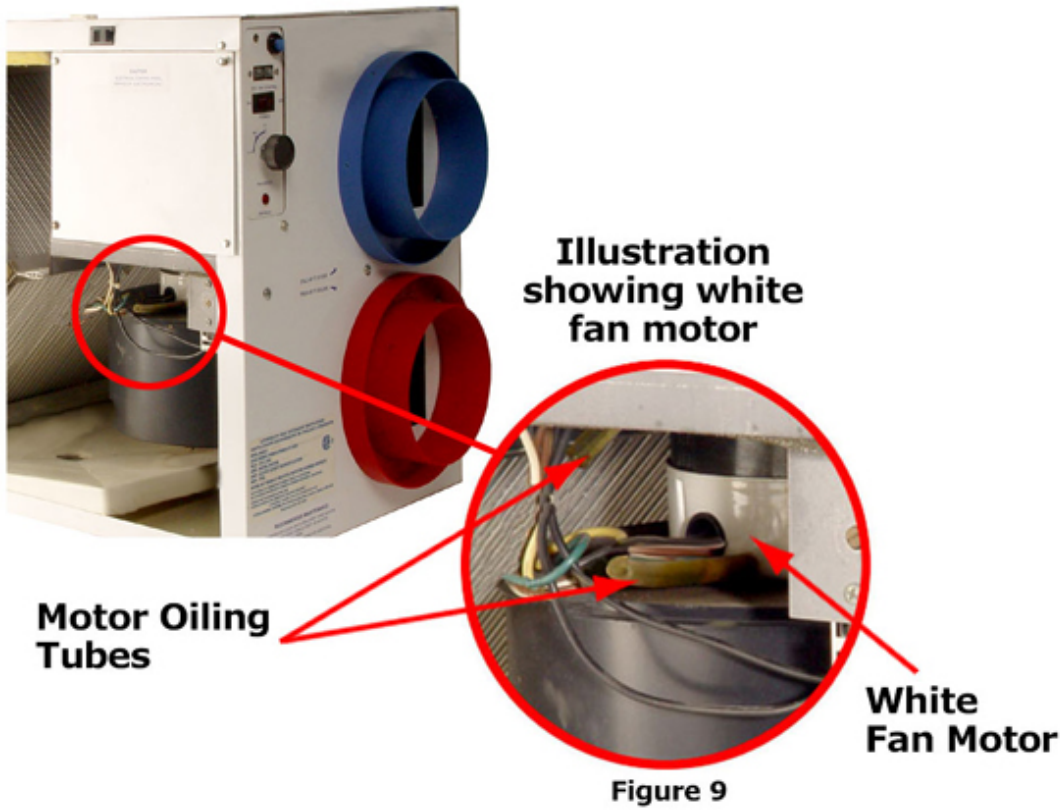
The fan motors of the affected *HRV's* are white in color. Please note that if the fan motor is not white in color, it does not need to be inspected under this program (**see figure 9 to identify location of fan motor**).
